Evaluation of titanium dental implants after early failure of osseointegration by means of X-ray photoelectron spectroscopy, electron microscopy and histological studies

In this work, we analysed 56 clinically failed and retrieved implants by means of scanning electron microscopy (SEM), X-ray photoelectron spectroscopy (XPS) and histological studies. The surface contamination was compared to that of unused control implants and with that of the same implants after cleaning in a basic medium. The surfaces of the unused implants presented considerable contamination. In particular, high levels of carbon were detected. The nature of this C was elucidated by XPS analysis of the lubricant used in the machining process. The same contamination was observed in the retrieved implants. Histological studies were carried out by means of light microscopy. Fibrosis and granulomatous lesions were detected in the tissues. XPS analysis indicated the presence of traces of other elements (Na, Ca, Zn, S, F, etc.) that were not related to impurities in cpTi. We examined a cleaning process in a basic medium that eliminates the organic components of the implant surfaces. The cleaned implants were implante

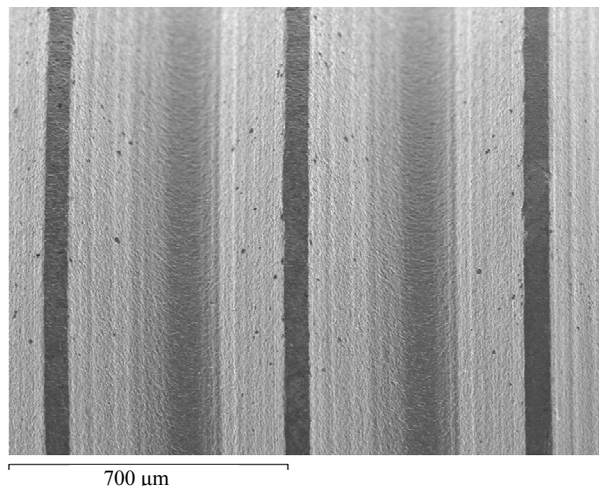
The SEM observations of the unused implants showed the roughness produced by the acid-etching process (H₂SO₄ and HF), as shown in **Figure 1**. At low magnification, the implants looked rather clean. However, at high magnification it was evident that some areas of the implant surface were covered by a dense layer of organic matter (**Figure 2**). This contamination was mainly on the upper part of the implant (near the prosthetic part).

Figure 1. Unused implant at low magnification.

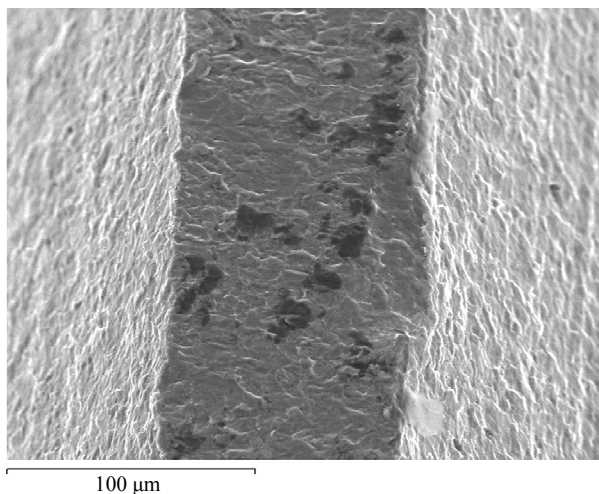
Figure 2. Dark stains found in the thread of an unused dental implant.

The as-received Ti implants displayed considerable surface hydrocarbon contamination (**Table 1**). On the surface, 40% atom C was found. These analyses exclude hydrogen, which is not detected by XPS. From the surface topographies revealed in the SEM micrographs (**Figure 2**), it seems unlikely that hydrocarbon would form continuously in layers. Rather, we suspect that the hydrocarbon was located mainly in the pits and pores on the plate surfaces. The amount of hydrocarbon detected on the plates varied.

Based on these analyses, we believe that the contamination is caused by the lubricants used in the machining of the implants. The chemical functions observed correspond to the fatty acids and amides found in the lubricant composition used. When removed by cleaning, these intensities decrease and in many cases disappear from the implant surfaces. The ultrasonic treatment is very important in the cleaning process because it favours the removal the organic contaminants [7-8].

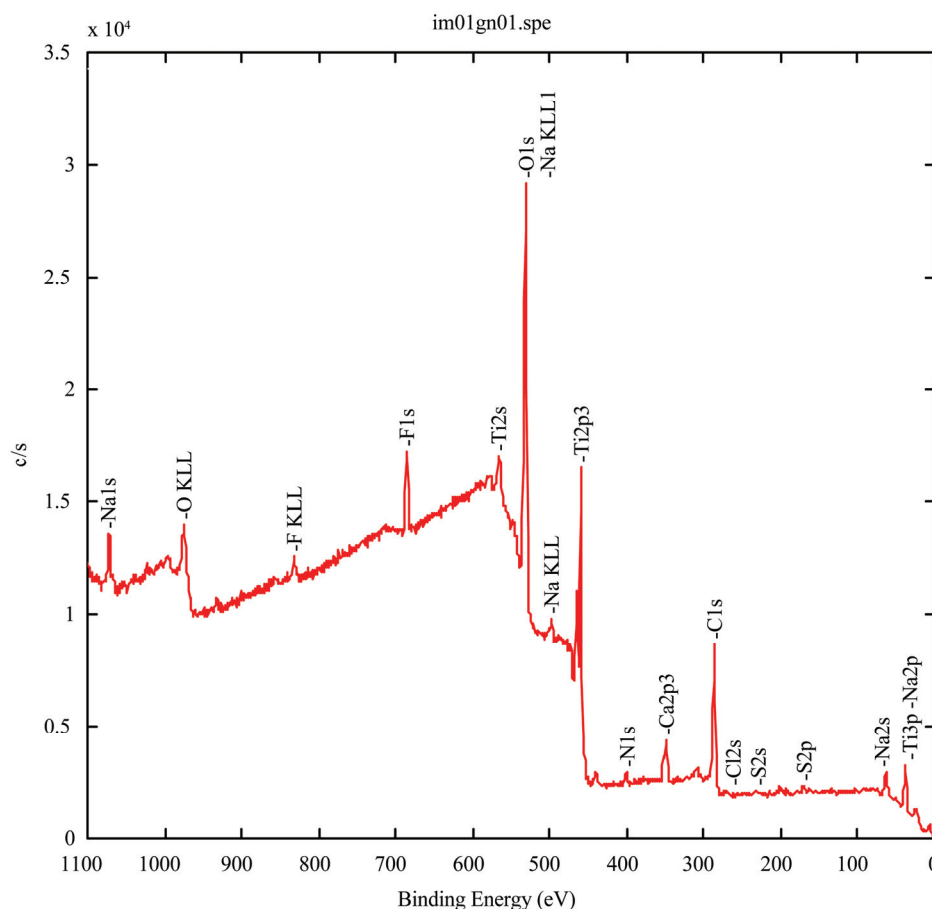
The nature of the hydrocarbon contamination was studied in greater detail. The narrow scan of the C 1s region was fitted using 4 peaks. The main peak is at 285.0 eV, with the subsequent peaks showing shifts of + 1.4, + 2.9 and 4.2 eV. The main peak is assigned to the C-C and C-H environment (48%) and the shifts are con-

sistent with the C-O (22%), C=O (16%) and O-C=O (14%) environments. From the intensities of the latter 3 peaks, we can see that the hydrocarbon contamination is O-rich. Oxygen signals were detected. The lowest, at a binding energy of 532 eV, can be assigned to TiO₂. The other signals at higher binding energies were consistent with various O functionalities: different forms of chemisorbed and physisorbed water on or within the TiO₂ surface and O-associated C. The nitrogen signal was detected at 401 eV, consistent with the following functionalities: -N-N-, -N=O [3-6]. An example of XPS spectrum is observed in **Figure 3**.

Figure 3. Wide scan XPS spectrum of an unused dental implant.
